Richmond Refinery LPS Bulletin – Reliability

Deisobutanizer (C-1400) Flooding

IMPACT ERM: 12224

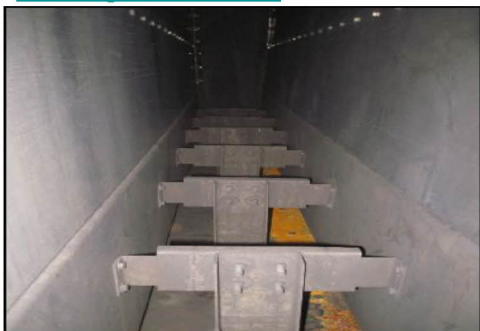
Orifices added to lower section of the tray 6 downcomer

3. Gamma scan results showed that there was a hydraulic limitation on tray 5. When the column was opened, no physical obstruction was found that would have caused the flooding.

4. The original column design of liquid downcomer clearance wasn't high enough to allow internal reflux at high unit feed rates. Subsequent modeling showed downcomer loadings were at the higher end of the acceptable range. This was not apparent before the 2010 Major T/A because the internal damage in C-1400 masked the design limitations of the column.

1. During the pit stop, the following modifications were made to the C-1400 trays and downcomers to prevent flooding in the future.
 - Orifices were added to the lower section of the tray 6 downcomer to reduce the resistance to liquid flow out of the bottom of the downcomer.
 - Deflectors were added to the vapor chimney open areas to reduce liquid entrainment to tray 6 and return fluid restriction of the vapor from tray 4.
